VISIBLE EMISSION OBSERVATION
KAISER STEEL CORPORATION,
FONTANA, CALIFORNIA

NATIONAL ENFORCEMENT INVESTIGATIONS CENTER

PREPARED FOR
ENVIRONMENTAL PROTECTION AGENCY

SEPTEMBER 1975

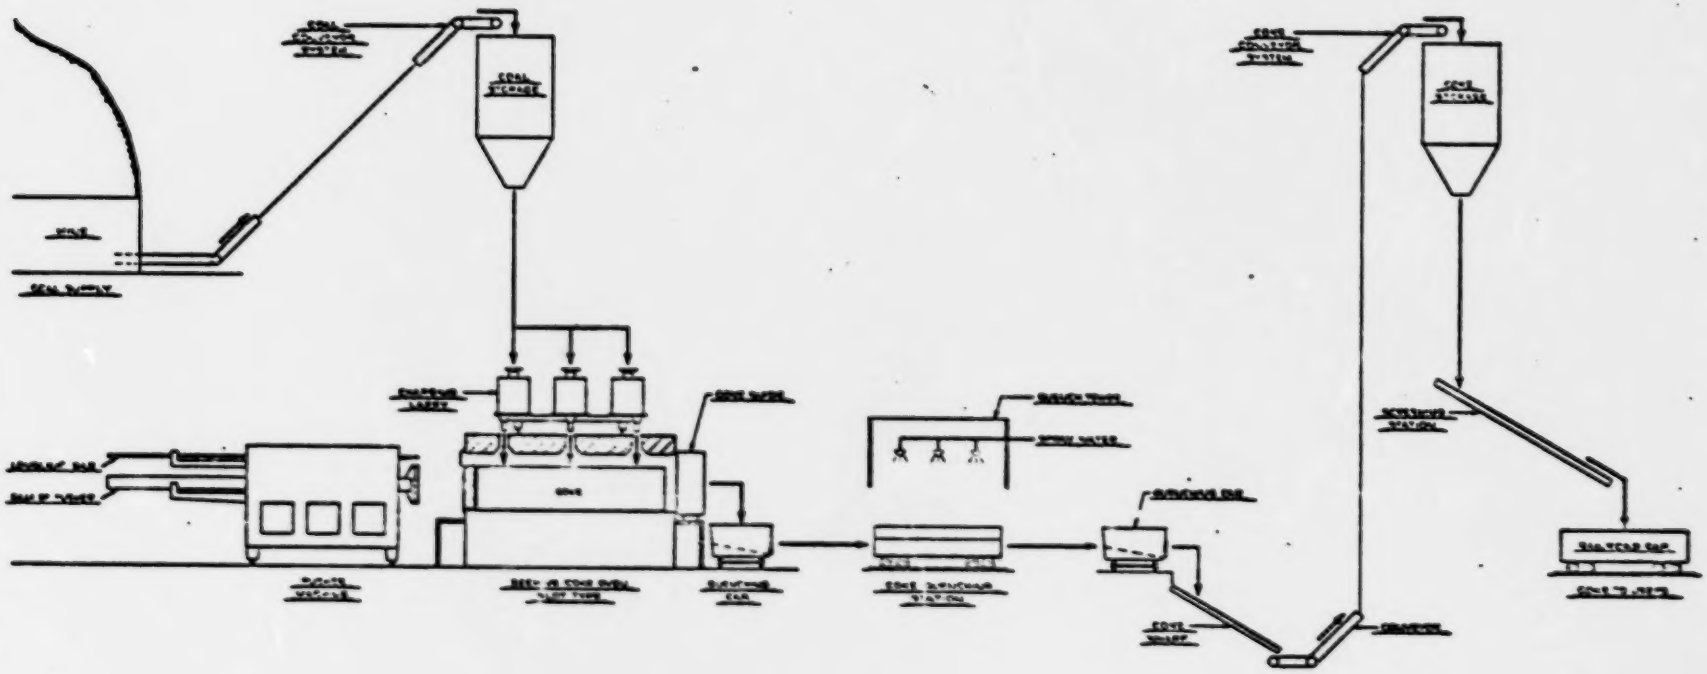
Figure IV-4. Typical Coke Oven Process Flow Diagram

Combustion gases from the flues are exhausted to the atmosphere through the main battery stack. If there are leaks in the oven walls,

volatile material from the ovens may also vent through this stack. Visible emissions occur when the coke is pushed into the quench car, and from the quench car, as it is moved to the quench tower. The quench produces visible emissions from the tower, along with large volumes of steam. Volatile materials in the ovens may escape to the atmosphere through leaks around the charging ports and oven doors and from leaks at blowoff valves on the gas standpipes or around the base of the standpipes. Emissions also occur from the charging ports during charging operations.

Visible emissions from the battery stack normally occur only when leaks into the flues from the ovens are present. Since the batteries are never shut down, maintenance to seal the leaks must be done while the ovens are hot. A silicone sealer is used for this purpose.

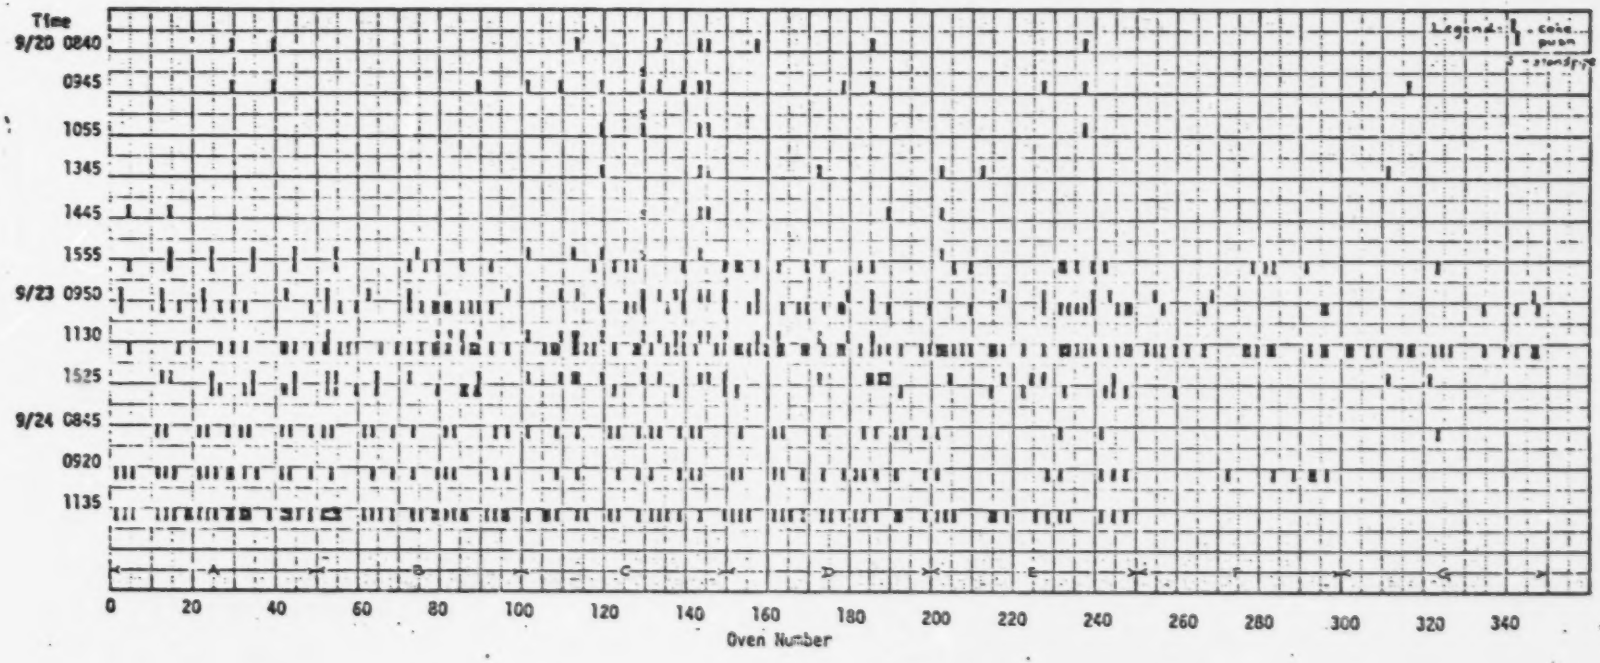
Figure IV-5. Observed Coke Oven Leaks

Observations were made of all ovens on three days to determine the frequency of occurrence of door leaks without regard to the opacity of emissions. The results of these observations are shown graphically in Figure IV-5. On 20 September, only the coke side of the battery was observed during the first five time periods. Beginning at 1555 hours, both sides of the battery were observed, as was the case for all three periods on 23 September. On 24 September, only the push side was observed. These observations indicated that door leaks occurred much more frequently on the push side, probably due to additional wear produced by the pushing ram and leveling bar striking the rim of the oven and chuck doors. Changes in pressure within the coke oven gas collecting system was the probable cause of changes in the number of door leaks. This is shown in Figure IV-5 for 1130 hours on 23 September and 1135 hours on 24 September when a large increase in door leaks occurred.

Closer examination of individual doors after charging indicated that in some cases the initial leakage emissions were from 20 to 40% opacity and sealed within 15 minutes. Others took longer to seal or were of a higher opacity. These high opacity emissions are summarized in Table IV-6 for the observations of leaks immediately after charging. Emissions from doors that took longer to seal are summarized under the observations taken during coking.

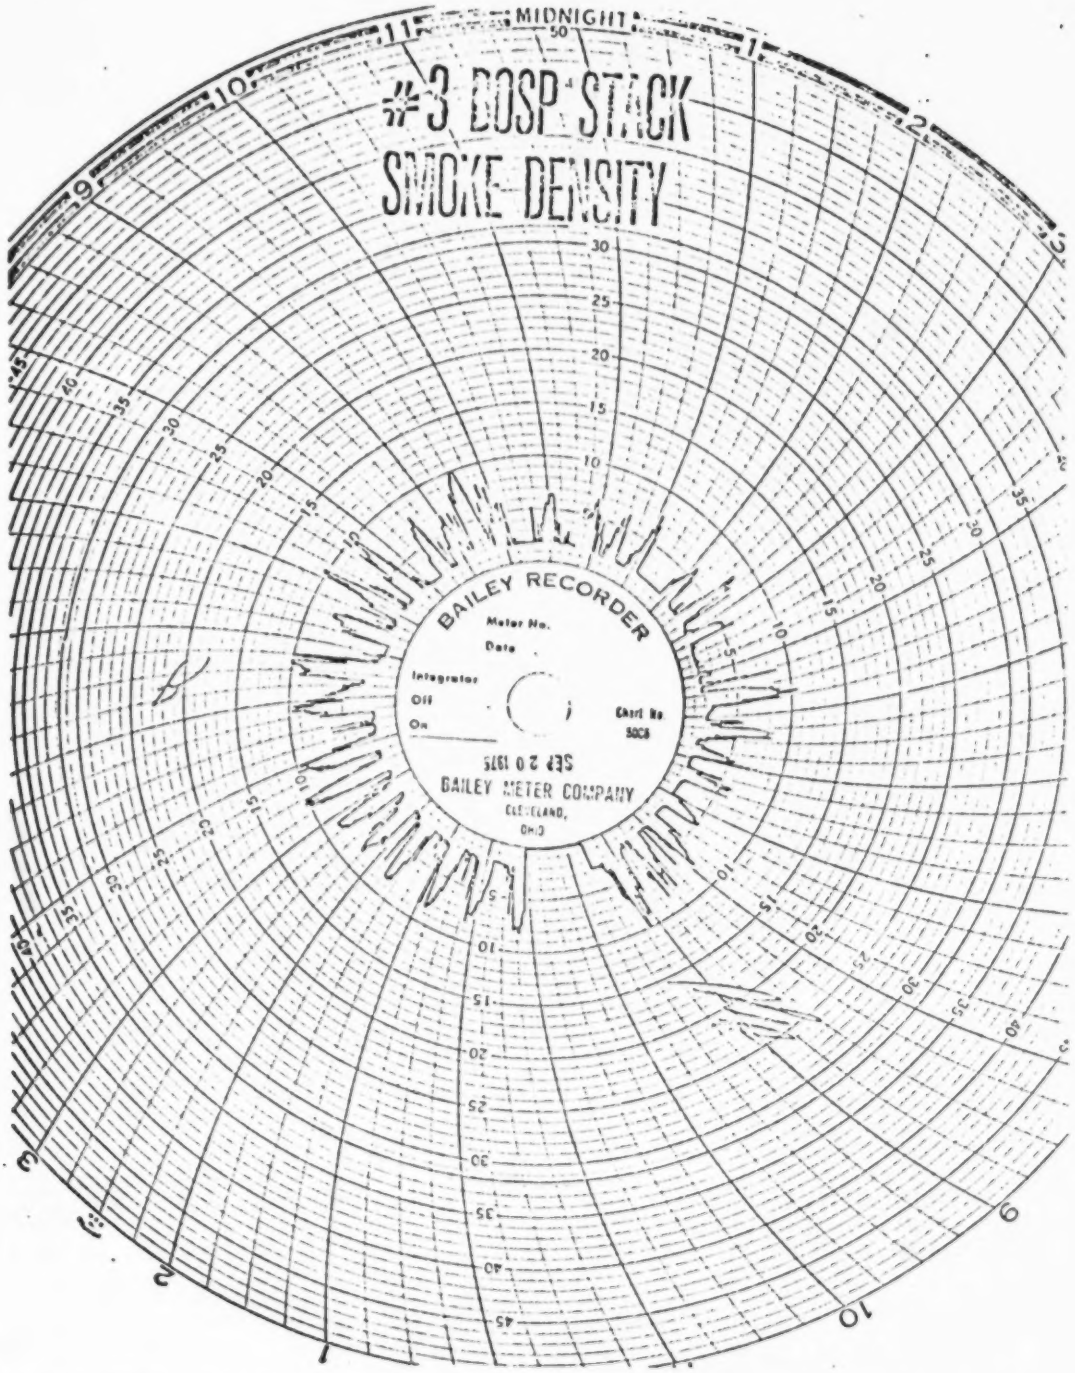
Figure IV-8. Smoke Density Readings-Stack No. 23, 20 September 1975

Examination of the smoke density recordings [Figs. IV-8, IV-9] indicates that emissions from stack No. 23 varied only slightly and were within acceptable opacity limits on both days illustrated, 20-21 September. The charts also show that the meters are kept in good repair since they continue to return to a 2% minimum, indicative of routine maintenance and the use of a live zero. On the other hand, similar charts for stack No. 21 [Figs. IV-10, IV-11] show that emissions from this stack were in excess of the Rule 50A limitation for about six periods each day. This is probably indicative of poor operation or maintenance of the ESP, but it is also directly related to the cyclical operation of the BOSP furnace.
